# SERVICE BULLETIN

OLIVIOL DOLLLIIV						
Classification:	Reference:	Date:				
HA08-002b	NTB08-053b	March 23, 2009

# 350Z-370Z; TAPPING NOISE FROM DASH AREA WHEN ENGINE IS RUNNING

**APPLIED VEHICLES:** 2007 – 2008 350Z (Z33)

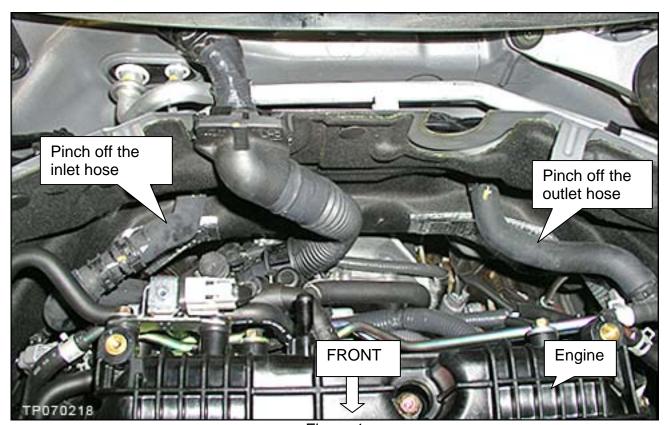
Figure 1

- 1. Confirm the noise is coming from the heater core as follows:
  - a. Confirm the engine is at operating temperature.
  - b. Turn the engine OFF.
  - c. Use blunt pinch clamps to pinch the heater core inlet and outlet hoses; this will stop the water flow through the heater core.
  - d. Start the engine and check for the noise; gradually increase engine RPM to 3500.

- If the noise is gone, this bulletin <u>applies</u>, go to step 2, next page.
- If the noise is still there, this bulletin <u>does not apply</u>; return to ASIST and the Service Manual for further diagnostic and repair information.
